OEM MECHANICAL SEAL PROBLEM SOLVED FOR POWER GENERATION EQUIPMENT MANUFACTURER

Cartridge Seal which was being used in Boiler Feed Pump had some leakage for which reconditioning was done

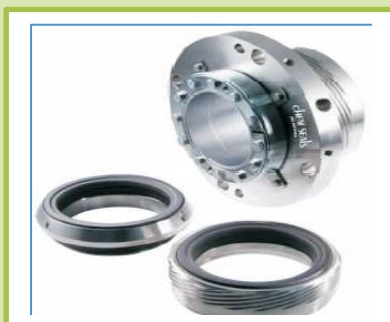
- Working Temperature – -180°C
- Pressure – 22Kg/cm^2
- Seal Size – 95mm
- Seal Type – Single Cartridge Seal

Our engineer first went to the factory to determine what was happening. Following the discovery of a leak in the cartridge seal in the boiler feed pump, we were sent the seal's drawings. The design was thoroughly inspected in the design department before handing the seal to the quality control department, where the faults were clearly highlighted and a plan of action was established. The seal was hydraulically tested after reconditioning to ensure that there were no abnormalities. After being thoroughly tested, the seal was installed in the site equipment.

At the location, a dynamic testing was conducted with the appropriate parameters to do the final test for seal in question, following which it was found to be working in perfect condition.

The Cartridge Seal was reconditioned at much lower cost than OEM and is still working perfectly.
