DRY GAS SEAL LEAKAGE PROBLEM SOLVED AT A MAJOR FERTILIZERS PLANT IN SOUTH INDIA.

Dry gas Seal was being used in root blower K-1203 for handling of nitrogen gas , where leakage problem was identified

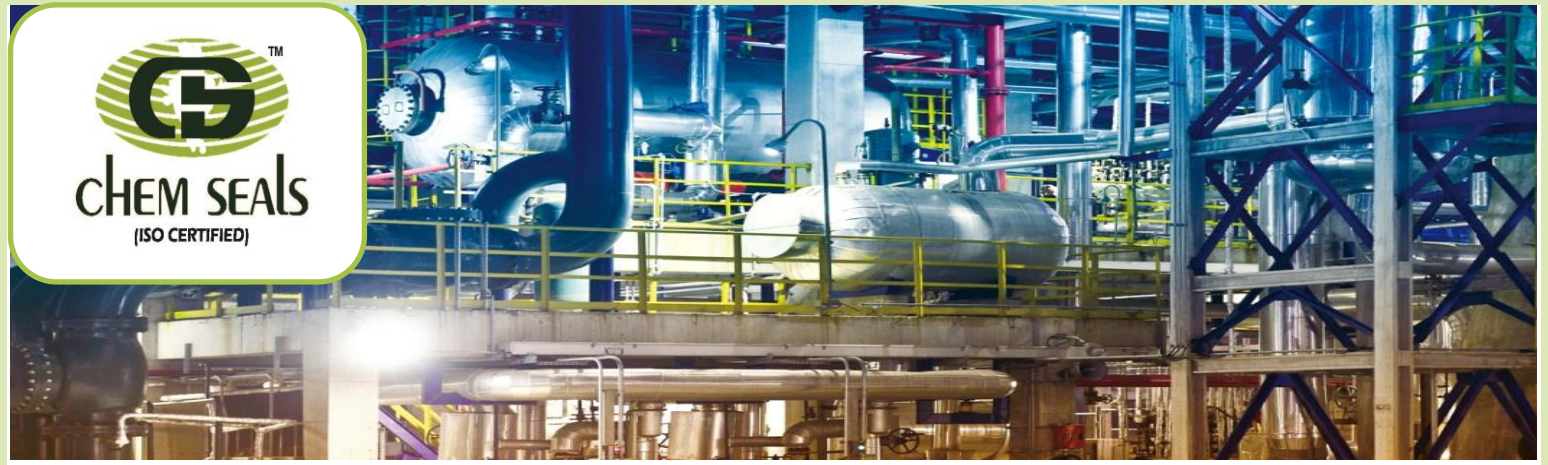
The breakdown of the dry gas seal resulted in nitrogen gas leakage, which was discovered. To resolve the aforementioned problem, all of the seal's technical parameters, as well as its dimensional drawing, were meticulously examined. The problem was detected and work on it began after all of the seal tests were completed at the quality control department.

The seal was reconditioned, the elastomers were replaced, and the seal was shipped to the plant after passing all essential testing.

Our engineer installed the seal after testing it on location.

The seal's performance was deemed sufficient, and has been performing at optimal conditions for last 3 years.

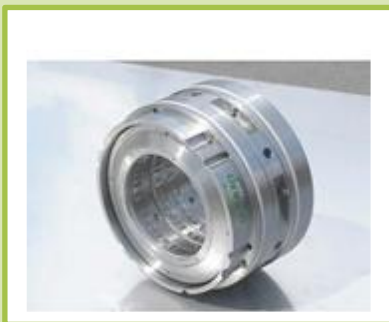
- Working Temperature -90°C
- Pressure - 6 Kg/cm²
- Seal Size - 4.625"
- Seal Type - CS 185 / DGS
- Media - Nitrogen
